FLUID BED REPAIRS AFTER HURRICANE KATRINA

PROJECT DATA SHEET

Southern US

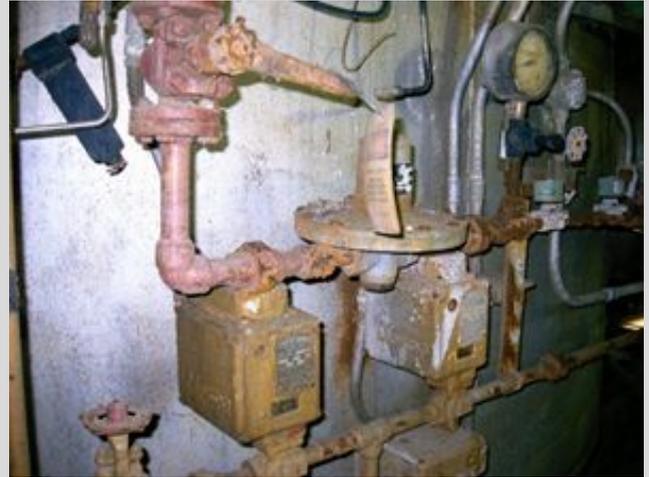
After Hurricane Katrina, the water treatment plant was under water for six weeks. Once the floodwaters receded, the incinerator needed to be rehabilitated to become functional. The rebuild included cleaning and repainting everything in the building, replacing some refractory in the furnace, and replacing almost all the ancillary equipment. This was done without the benefit of the original documentation, which was lost in the flood. The entire controls system was replaced with a state-of-the-art system. The furnace required testing for EPA compliance, and required coordination between IFCO, the plant, and the EPA. Equipment repaired or replaced included the entire Instrumentation and Controls System, combustion system, feed system, roof sprays, blowers, scrubber (repairs), and oil and gas injection system. In 2012, IFCO performed more repairs after Hurricane Isaac flooded the building again. This damage was not as extensive, and only required the items located in the basement to be replaced.

DAMAGE FROM HURRICANE KATRINA

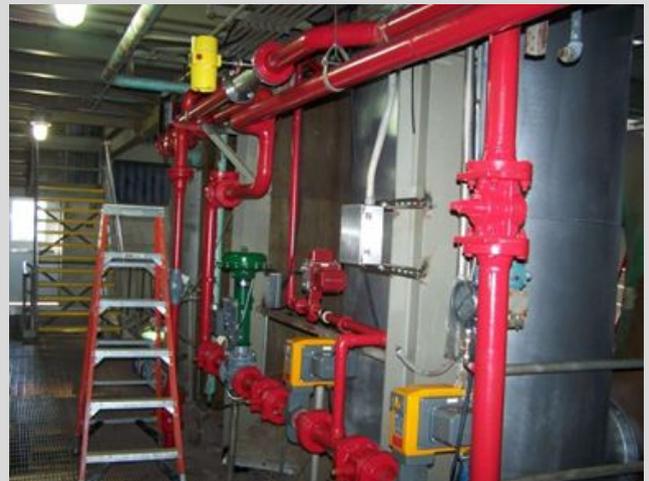
AFTER IFCO REHABILITATION
